**RESEARCH DEPARTMENT
Bulletin 203**

**Surface Discoloration of
Concrete Flatwork**

**By
N. R. Greening and R. Landgren**

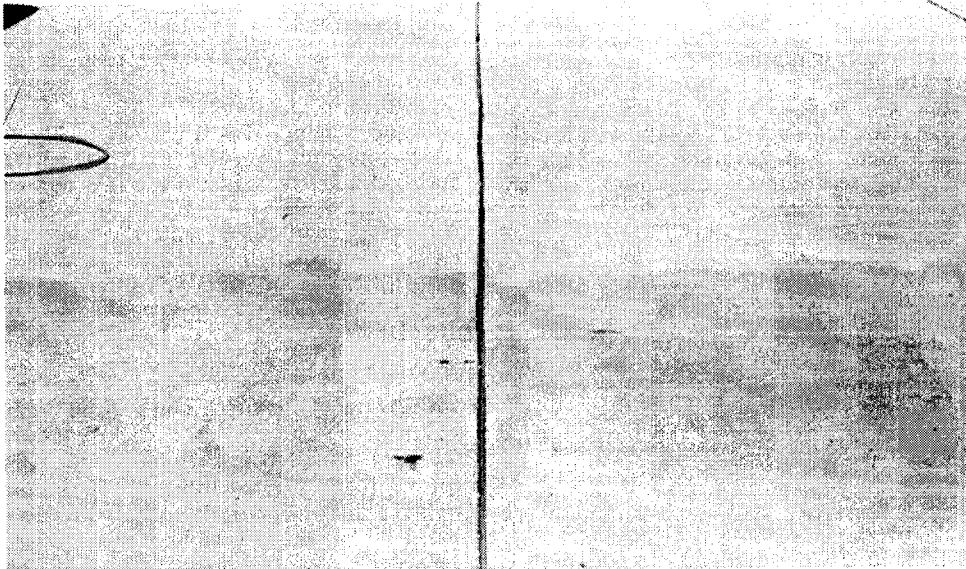
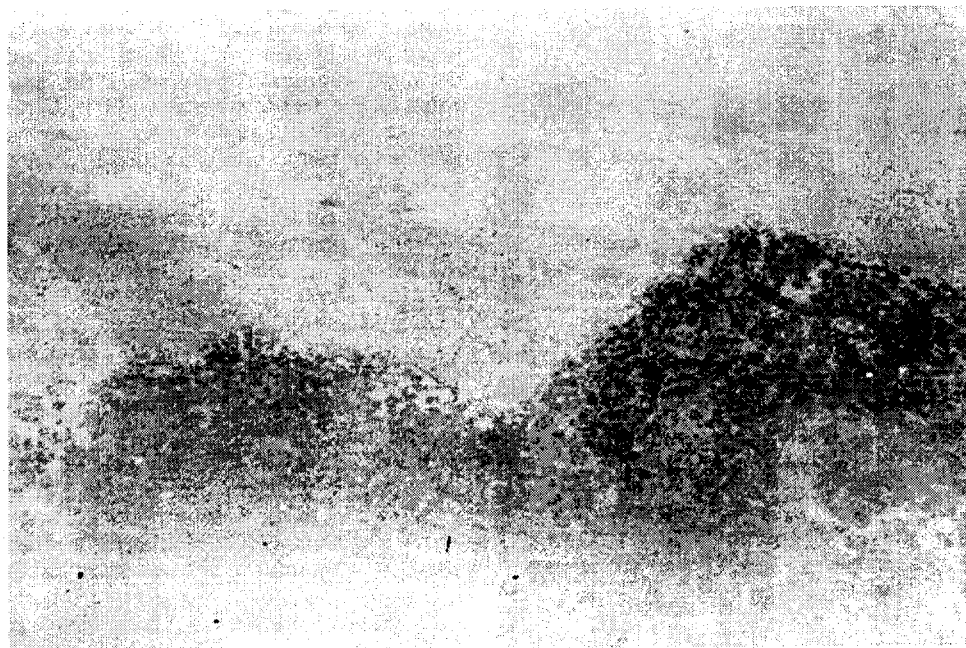
Fig. 1—A Driveway with Gross Color Contrast and Mottling Discoloration.

(a) Overall View. Concrete in foreground contained calcium chloride, that in back did not.

(b) Closeup of surface.

concrete flatwork job. This discoloration may take the form of: (1) gross color changes in large areas of concrete caused as in Fig. 1(a) by changes in the concrete mix; (2) spotted or mottled discoloration where light or dark blotches appear on the flatwork surface, as in Fig. 1(b); and (3) early discoloration by light patches of "efflorescence." These discolorations appear soon after the flatwork has been placed and are due in the latter two cases to the procedures used to cast, finish, and cure the slab.

Fig. 1(a) shows an attempt made in the field to shorten overall finishing time, by switching to concrete containing calcium chloride, after first placing concrete without an accelerator. The photograph was made five years after casting. The dark area is a classic example of chloride discoloration. Even if the mottling discoloration had not occurred, the overall dark color of the concrete containing calcium chloride

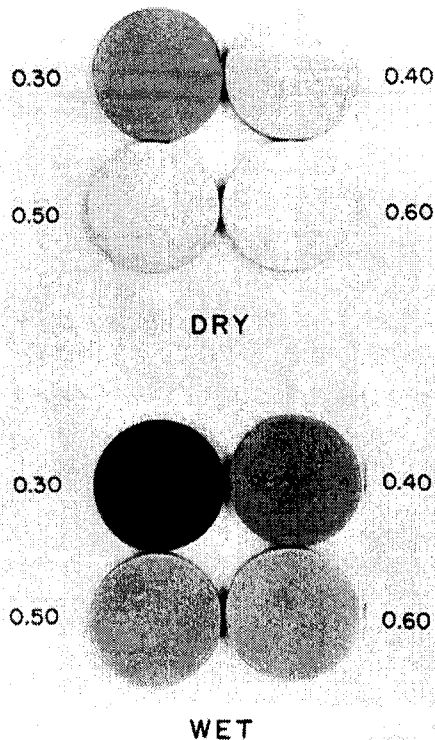
Fig. 2—Effect of Water-Cement Ratio on Color of Seven-Year-Old Pastes.

A low water-cement ratio paste is almost always darker than a high water-cement ratio paste made with the same portland cement. This is evident in Fig. 2, which compares the color of mature pastes, both wet and dry, made with water-cement ratios of 0.3, 0.4, 0.5, and 0.6 by weight. All pastes were made with the same cement. Construction practices producing localized areas of variable water-cement ratio within a slab are potential causes of discoloration.

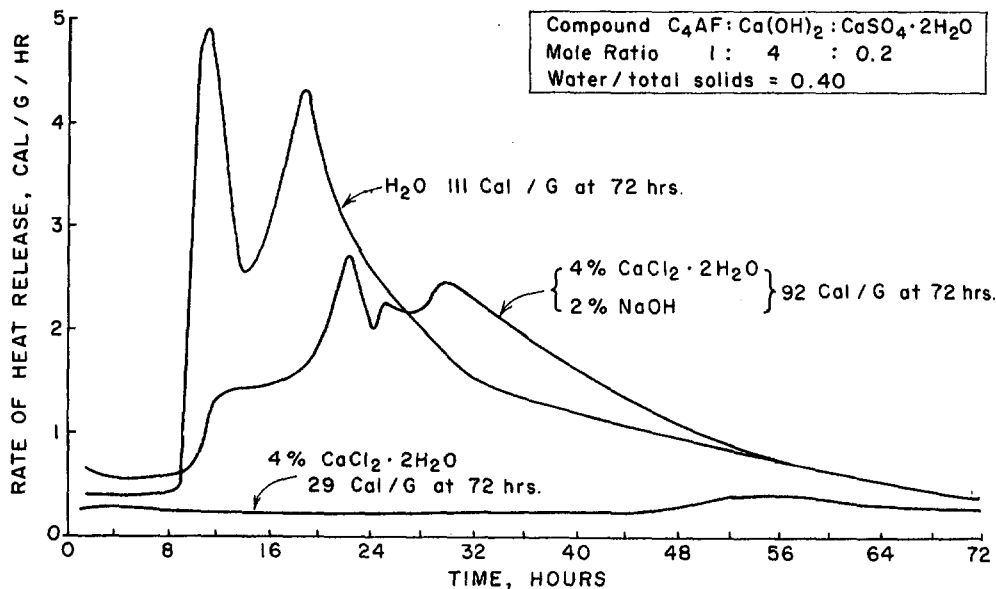
Fig. 3 — Effect of CaCl_2 and NaOH on Hydration of C_4AF .

Fig. 3 illustrates the effect of calcium chloride and alkalis on ferrite hydration. Shown are curves of conduction calorimeter rate of heat release for mixtures of synthet-

ic C_4AF^* (of the fineness of cement), gypsum, and excess calcium hydroxide reacting in the presence of the indicated solutions. These data show that the C_4AF in this system hydrates rapidly after about 8 hours in water. When the same mixture reacts in 4 percent calcium chloride solution instead of water, the hydration rate is greatly reduced. After 3 days, the hydration in calcium chloride solution is only one-fourth that of the same mixture in water. However, if 2 percent NaOH is added to the 4 percent calcium chloride solution, the alkali almost overcomes the retardation caused by the calcium chloride alone.

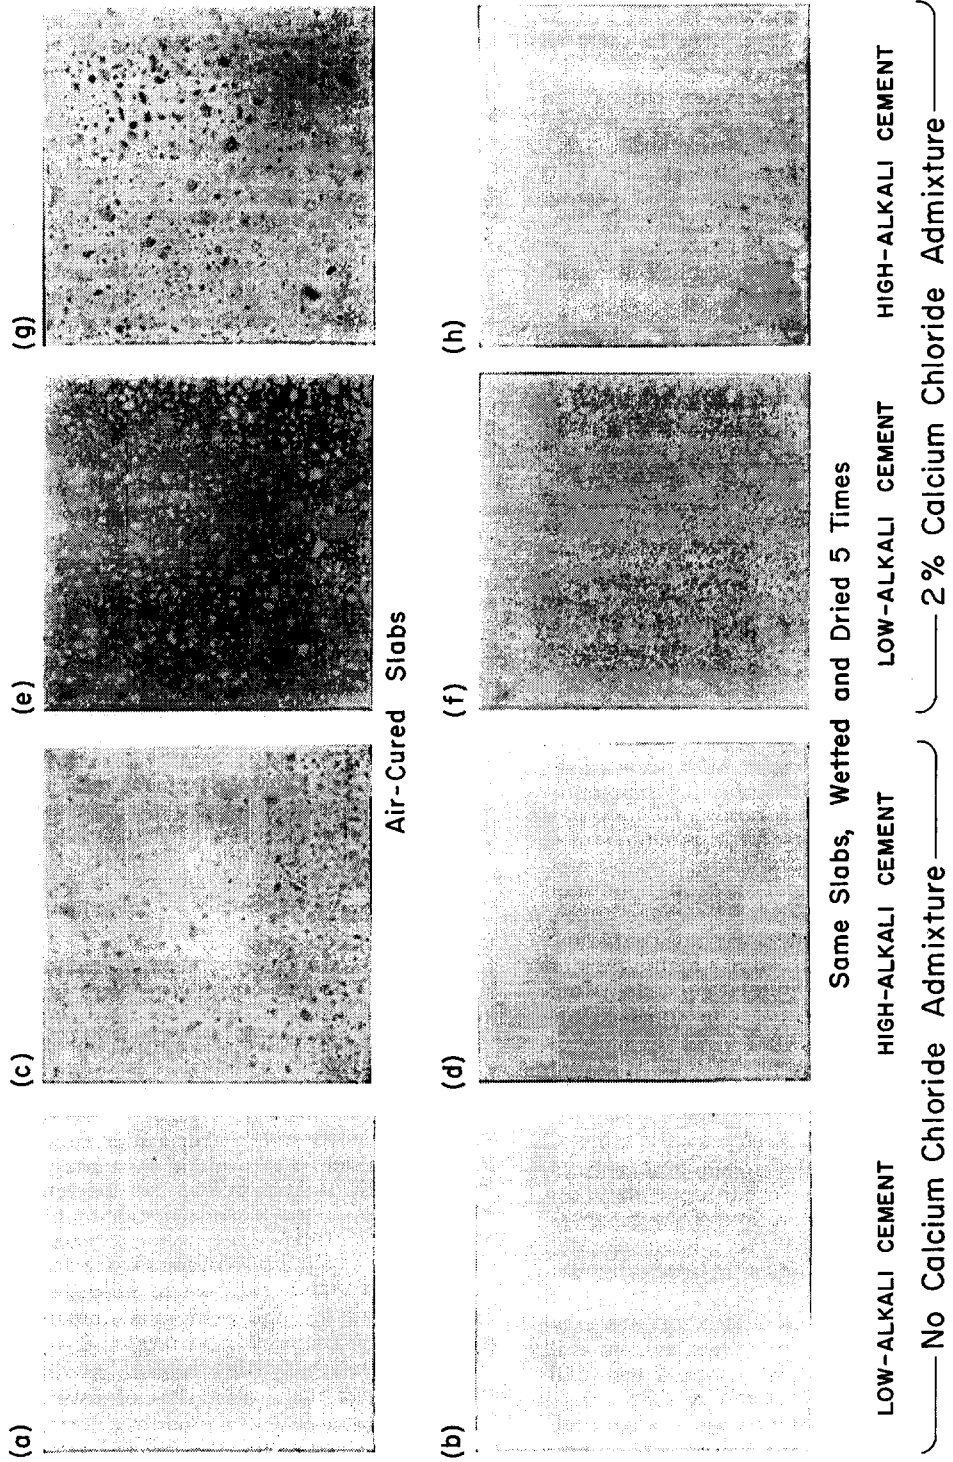
Fig. 4—Effect of Calcium Chloride Admixture on Hard Troweled Slabs.

Fig. 4(a) shows the surface of a concrete slab made with low-alkali cement A without calcium chloride. The slab is free of discoloration. Washing did not alter its appearance (see Fig. 4(b)).

Fig. 4(c) shows a similar concrete slab made with high-alkali cement B, also without calcium chloride. This slab is definitely discolored with dark spots, but the discoloration is temporary and disappears when the slab is treated five times by alternately hosing it thoroughly with water and drying it overnight (see Fig. 4(d)).

The slab of Fig. 4(e) is exactly like that of 4(a) except that it contains calcium chloride. The extreme discoloration is characterized by light spots directly over coarse aggregate particles near the concrete surface. The dark surface matrix is over relatively deep mortar. Severe discoloration (Fig. 4(f)) was still evident on this slab surface after the 5-day washing and drying treatment just described.

Fig. 4(g) shows the surface of a concrete slab made with high-alkali cement B and with calcium chloride. Except for the calcium chloride, the slab is identical with the (c) slab. The washing and drying treatment alleviated the original discoloration (see Fig. 4(h)), but not as easily or successfully as for slab (c).

Slabs (e), (f), (g), and (h) of Fig. 4 contained 2 percent flake calcium chloride by weight of cement. Higher percentages of this accelerator are rarely intentionally used in concrete. Available evidence indicates that the magnitude and permanence of discoloration increases as the calcium chloride concentration increases from 0 to 2 percent, provided other factors remain constant.

The dark spot discoloration shown in Figs. 4(c) and 4(g) appears to be caused by alkali salts that migrate to the drying concrete surface and concentrate in the more porous or checked areas of the surface. These deposits of salt are relatively transparent and continuous. Their optical behavior is apparently similar to that of water or clear oil, which will darken paste when absorbed. Microscopic examination indicated that the materials causing dark spots on slabs without calcium chloride (Fig. 4(c)) were alkali carbonates—reaction products of cement alkalis and carbon dioxide from the air. Dark spots on slabs containing calcium chloride (Fig. 4(g)) are primarily crystalline potassium and sodium chloride—reaction products of cement alkalis and calcium chloride. The simplest remedy for either type of discoloration is to wash away the discoloring salt with water. One washing was often sufficient for the dark spot type of discoloration which occurred in the absence of calcium chloride. If the concrete contained calcium chloride, repeated washings were necessary to remove the dark spots completely. Somewhat inconclusive data suggest that this washing treatment becomes less effective as the concrete ages.

The light spot type of discoloration (Fig. 4(e)) is particularly difficult to remedy. However, washing or weathering causes the dark background areas of these slabs to lighten very slowly, approaching the color of the lighter spots. It appears that discoloration by salts, such as that described for the dark spot type of discoloration, is relatively minor. The first washdown with water perceptibly lightens the slab, probably by removing the relatively small amount of salt at the slab surface.

The light spots on the surface of Fig. 4(e) coincide exactly with particles of coarse aggregate close to the slab surface. These relatively impermeable particles interfere with the normal migration of chloride salts toward the drying surface of a concrete slab, resulting in differences in the extent of hydration of both the ferrite and silicate phases. This produces light spots (low calcium chloride content) over the aggregate, which contrast with dark (high calcium chloride content) surface areas over deep mortar. The migration of chloride salts toward the drying surface of the slab significantly increases the surface concentration of these salts. Limited chloride analysis indicates that surface mortar of air-dried slabs has three to four times the original concentration of chloride.

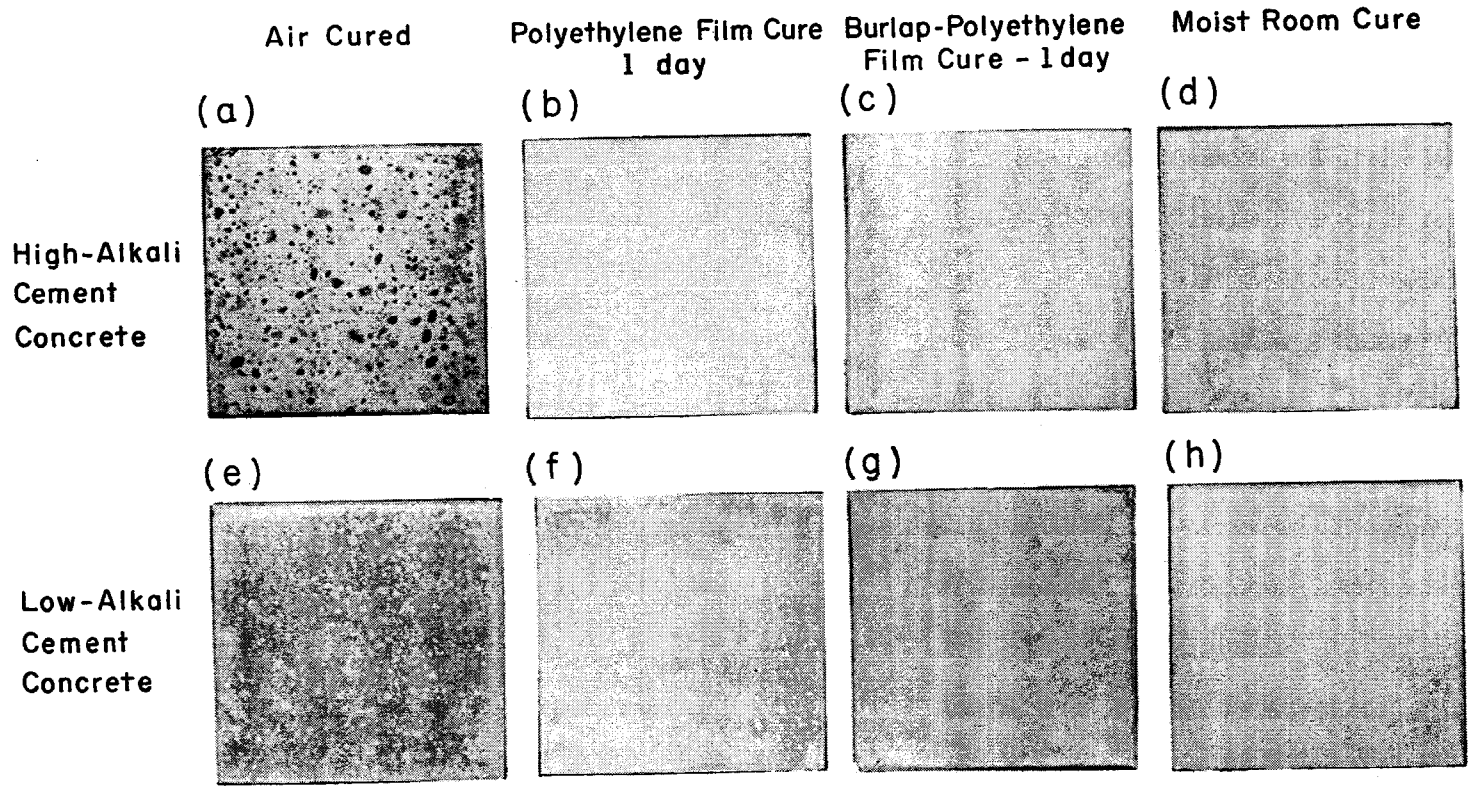
Fig. 6—Effect of Curing on Discoloration of Hard Troweled Slabs Containing 2 Percent Calcium Chloride Admixture.

Effectiveness of Various Curing Procedures. Fig. 6 shows the effects of different curing procedures on the mottling discoloration of cement B and A concretes containing calcium chloride admixture. Both air-cured specimens, (a) and (e), were badly discolored. High-alkali concrete slabs that were given 1 day of polyethylene curing, (b), or burlap-polyethylene curing,

(c), or were moist room cured, (d), displayed little discoloration, indicating the effectiveness of most curing procedures in preventing such discoloration.

One day of burlap-polyethylene curing, (g), and moist curing, (h), appeared reasonably effective in preventing discoloration in low-alkali concrete slabs. One day of curing under a polyethylene film, (f), was not sufficient. The inadequacy of the 1-day polyethylene cure in this instance suggests that thoroughness of curing is essential to prevent discoloration of low-alkali calcium chloride slabs.

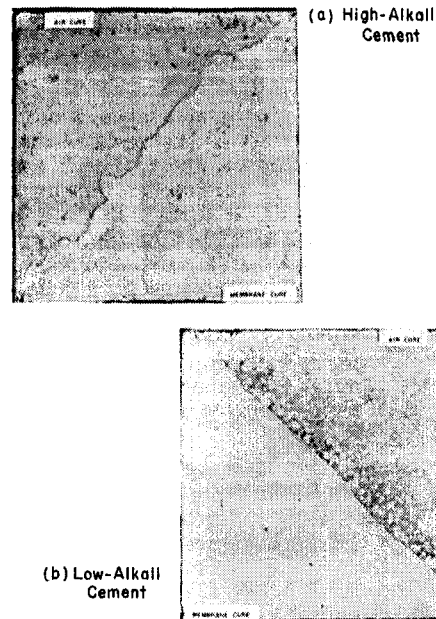
Fig. 7—High- and Low-Alkali Cements Used in Concrete Slabs with 2 Percent Calcium Chloride. A Portion of Each Slab Was Painted with Membrane Curing Compound, Which Was Removed with Solvent After One Day.

Uneven Curing. The overall color of the air-cured portion of the slab in Fig. 7(a) stayed noticeably darker than the membrane-coated portion. This condition is probably permanent. It is a good example of discoloration from uneven curing. To prevent discoloration from this cause, membrane curing compound should be applied evenly and adequately, moist coverings should be kept uniformly wet, and plastic film covers should be thoroughly anchored.

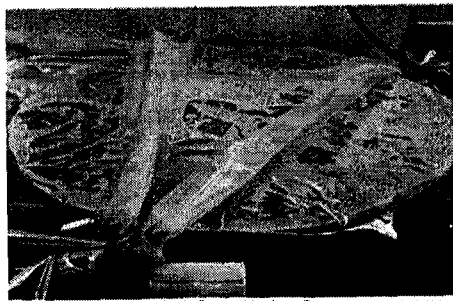
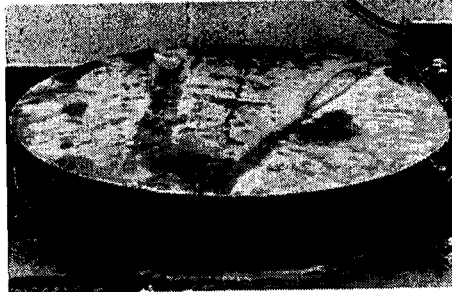
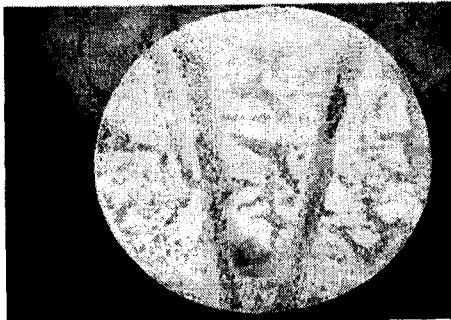
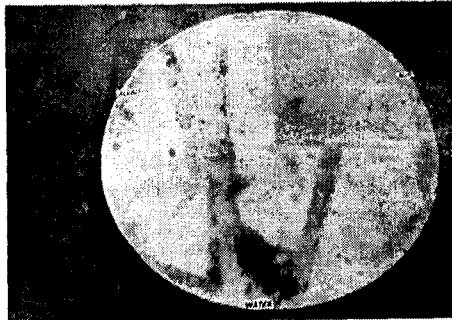
Fig. 8 — "Greenhouse Effect" Discoloration of a Hard-Troweled, High-Alkali Cement Slab Containing 2 Percent Calcium Chloride.

(a) Slab Under Cure

(b) The Morning After

(c) Washed and Dried Slab

(d) Results of Corrective Treatments

"Greenhouse Effect." Careless placing of plastic curing film on the surface of the flatwork concrete containing calcium chloride may cause unsightly efflorescence deposits in addition to mottling discoloration. A high fold in a waterproof curing sheet can serve as a little "greenhouse." On

a hot day, under direct sunlight, the fold becomes the location of a water evaporation-condensation cycle. The heat of the sun, aided perhaps by the heat of hydration of the concrete, evaporates water from the concrete under the fold. The water vapor then condenses on the cool high part of the fold and eventually runs down the sides of the film to collect at the points of intersection of the concrete and the film, or in low places in the concrete surface. Such localized dry and wet areas on fresh concrete surfaces may cause concrete discoloration.

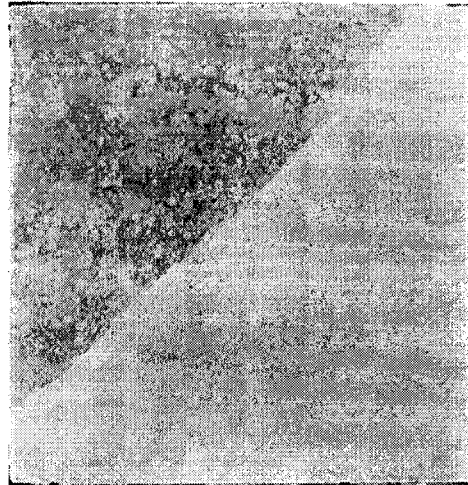
Fig. 9—Half of This Slab Was Treated with Di-Ammonium Citrate to Remove Light Spot Discoloration.

Fig. 9 shows a badly discolored slab, the light portion of which resulted from two ammonium citrate treatments (described below). Some of the lightening is caused by the gel "whitewash," but there has also been a pronounced change in the nature of the discoloration. Further treatments with the chemical, alternated with wetting and drying, produced even more lightening of the concrete surface and made the treated surface even more uniform in color.
